OFIL SYSTEMS

# NEWSLETTER

## Why UV Corona Imaging Is Becoming an Industry Standard

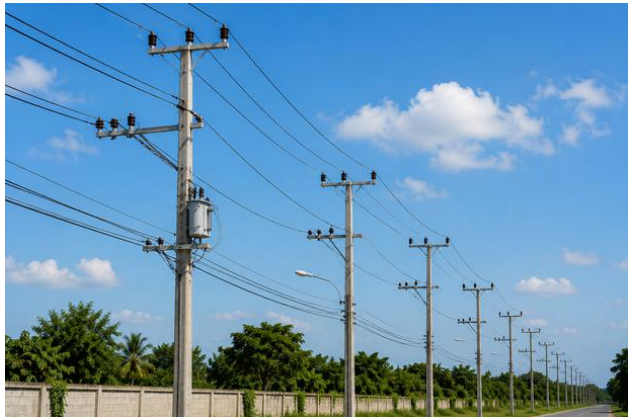
Corona and UV inspection are commonly associated with high-voltage transmission lines. Transmission networks carry large amounts of electricity over long distances, typically at voltages ranging from approximately 69 kV to more than 700 kV. Distribution networks serve a different purpose. They carry electricity from substations to homes, businesses, industrial facilities, and public infrastructure. Primary distribution systems typically operate between approximately 4 kV and 35 kV before transformers reduce the voltage further for end users.

UV inspection is often overlooked on distribution networks because of the misconception that corona discharge is only relevant at transmission voltages. In practice, distribution assets can develop corona, gap discharge, and arcing due to damaged or contaminated components, inadequate clearances, poor grounding, loose connections, and installation defects. These networks should therefore be included in UV inspection programs, particularly because they operate close to customers and frequently have limited redundancy.

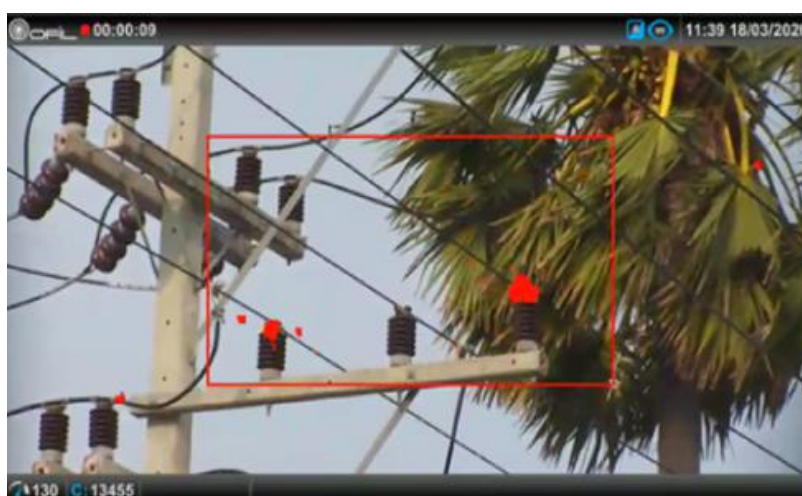
### Corona Activity on Distribution Insulators

Periodic UV inspection detected corona discharge at the live end of insulators on two phases, where persistent activity could damage the insulation and its hydrophobic coating and increase the risk of failure in humid or wet conditions.

Early detection enabled the insulators to be replaced during a scheduled outage, reducing the risk of unexpected failure and service interruption.

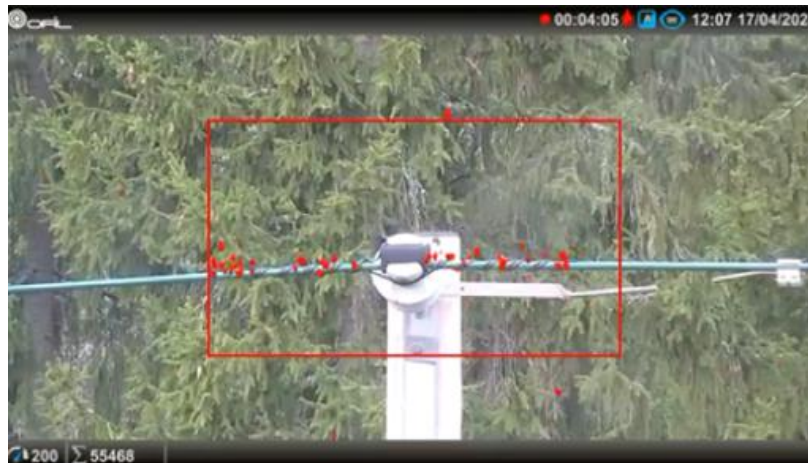
### Hidden Tie-Wire Discharge Detected by UAV

A UAV-mounted UV camera detected corona partial discharge on a tie wire that appeared normal during visual inspection. The discharge was caused by improper installation of the tie wire and was damaging the insulation material.

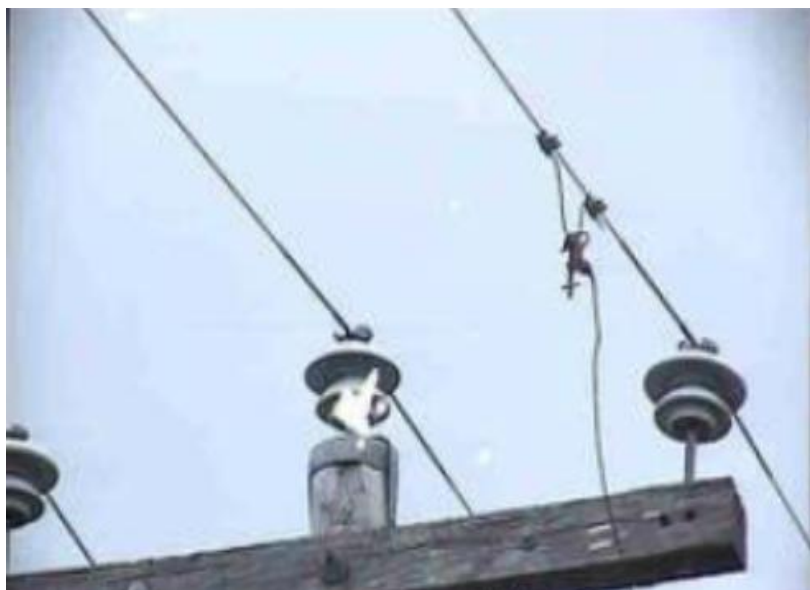
### Critical Insulator Failure & Voltage Leakage

UV inspection detected corona discharge at the dead end of a distribution-line insulator, indicating insulator failure and voltage leakage toward the pole. This presents a serious safety hazard and requires immediate corrective action.
