# **3** / OPERATIONAL MAINTENANCE

# OUR PROCESS FACILITATES YOUR SUCCESS

# **3 INTELLIGENT DESIGN MEETS CUSTOM ENGINEERING**

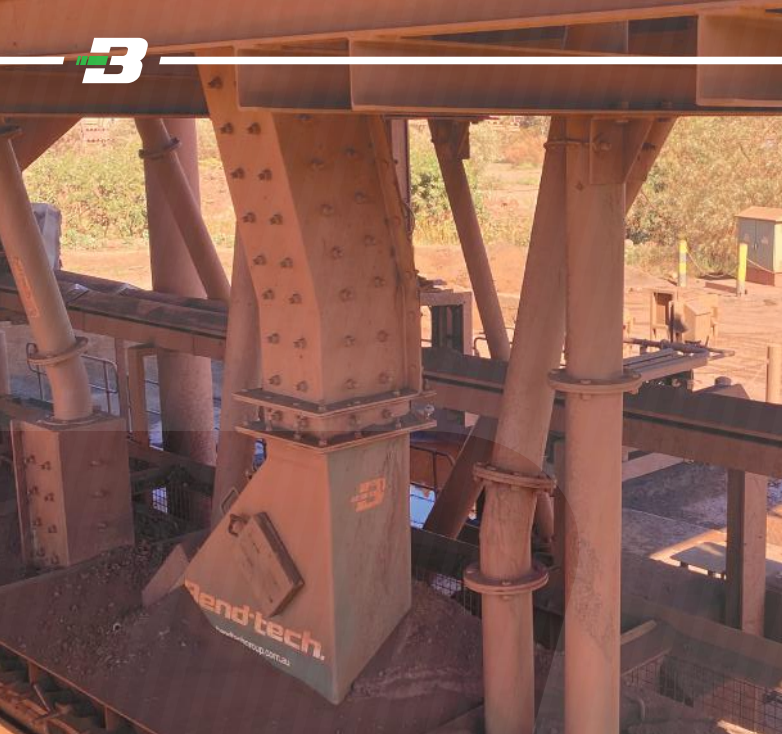
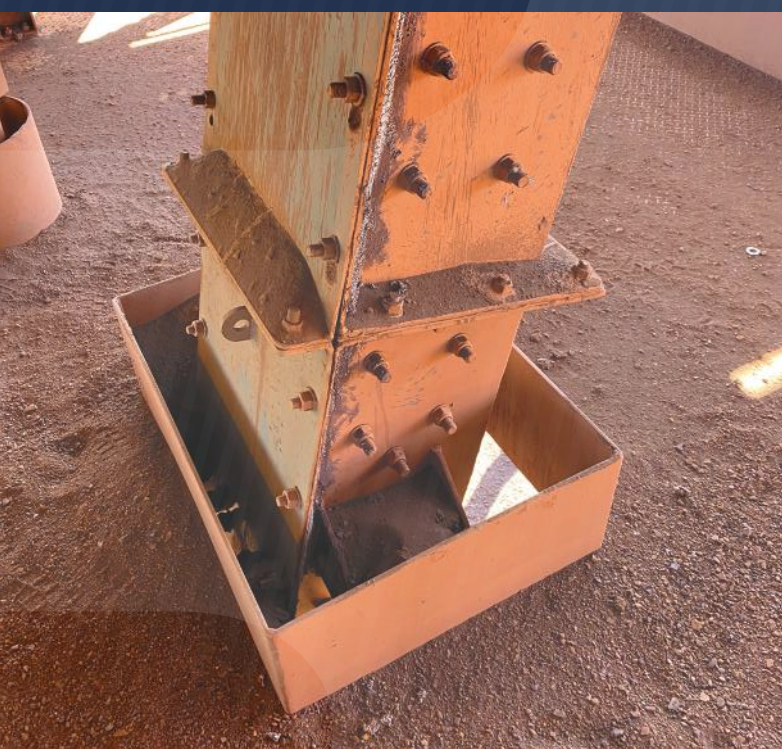
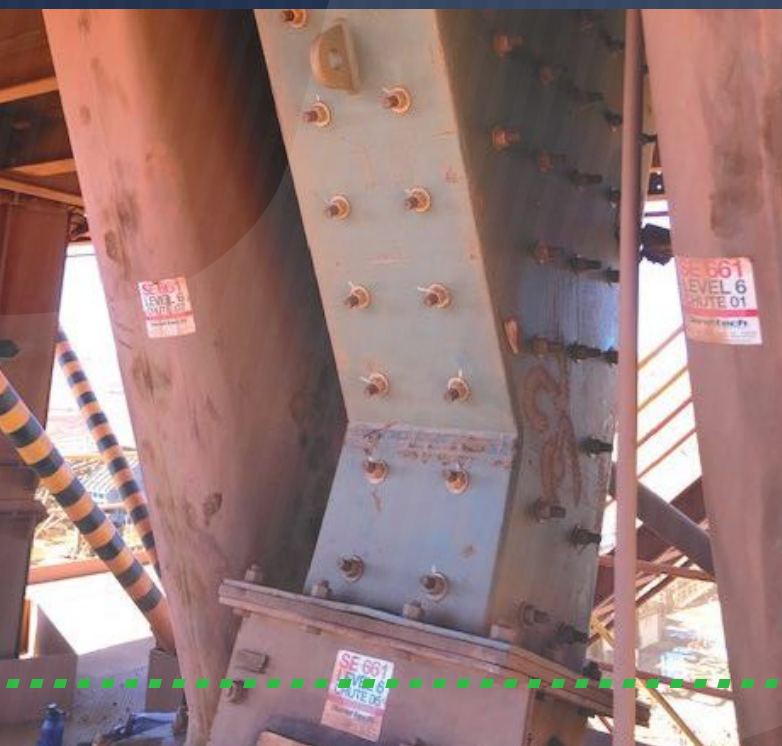
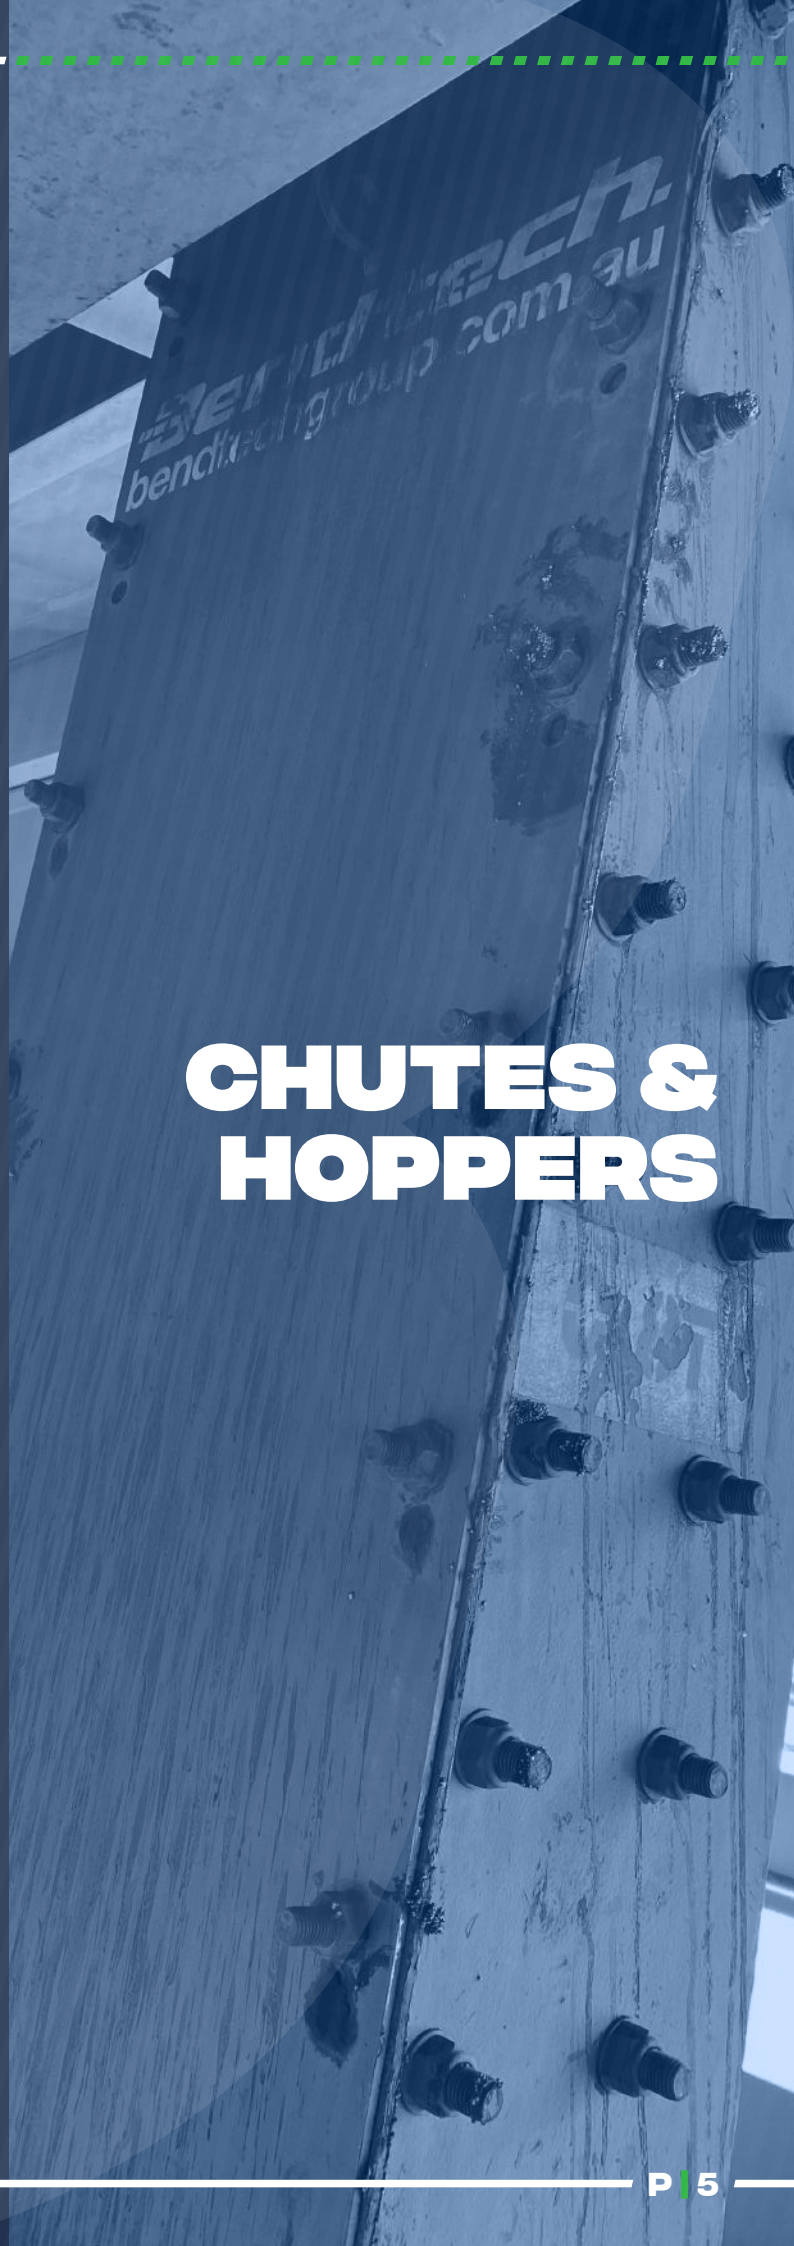
# ACCESS DOORS

## 1<sup>ST</sup> / LEVEL OF SAFETY

THE OUTER DOOR IS FITTED WITH RUBBER SEAL TO REDUCE VIBRATION AND NOISE.

## 3<sup>RD</sup> / LEVEL OF SAFETY

THE CROSS SECTION IS THE LAST LINE OF A STRONG SAFETY SYSTEM, PREVENTING OPERATORS FROM FALLS.

## 2<sup>ND</sup> / LEVEL OF SAFETY

THE JAIL BAR DOOR PROTECTS OPERATORS WHEN THE OUTER DOOR IS OPEN FOR INSPECTION.

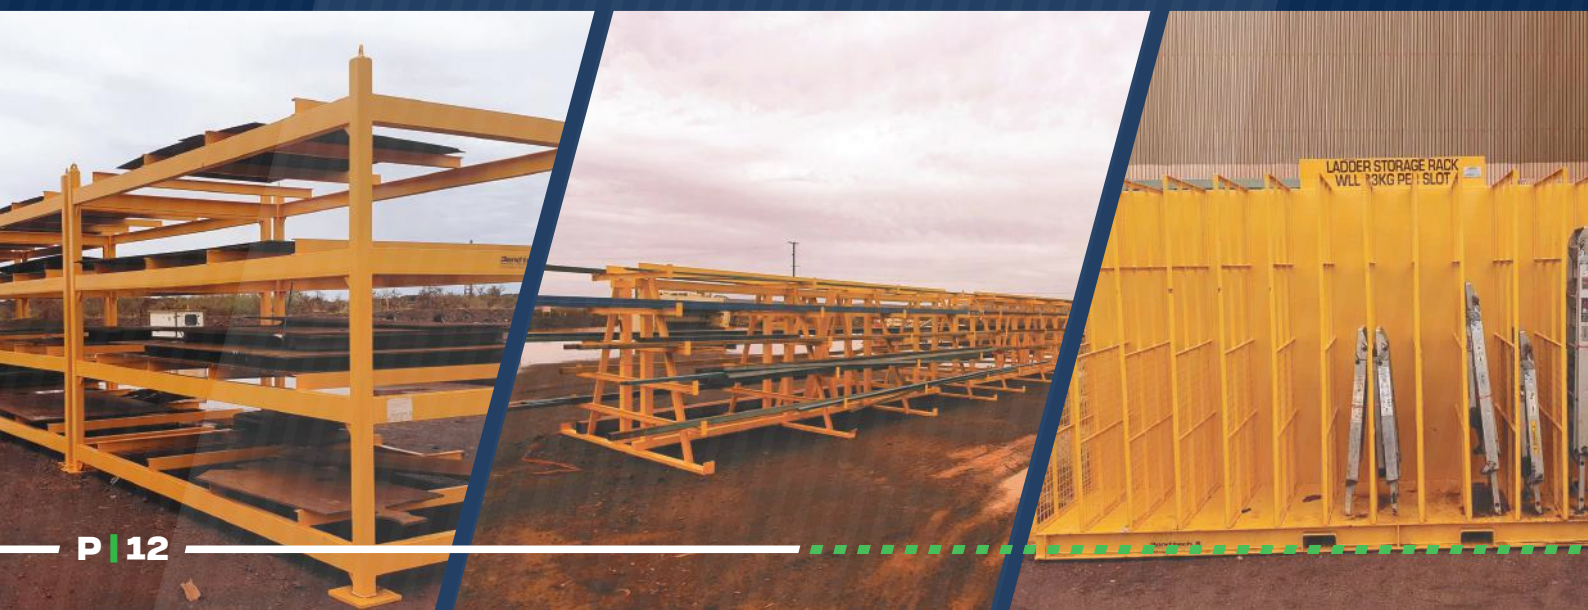
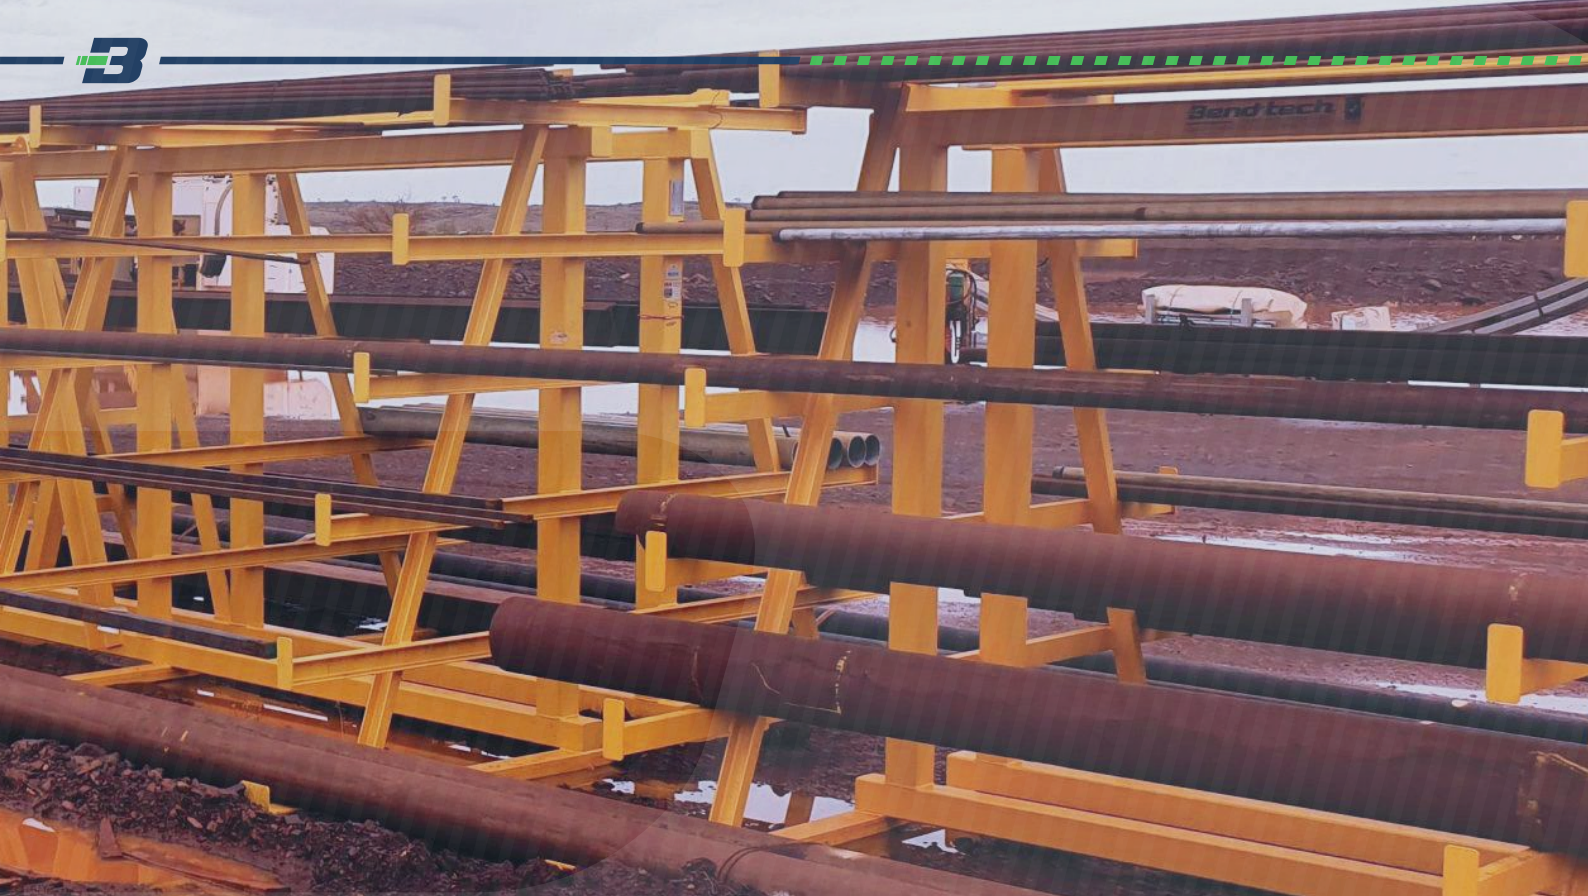
## STEEL RACK CITY

On arrival it was impossible not to notice the seemingly endless lines of Bend-tech's steel racks in the yard. Custom designed steel pipe storage racks were stationed side-by-side on the Pilbara's red dirt, along with five flat plate racks to store the site's variety of steel pipes and plates safely and efficiently.

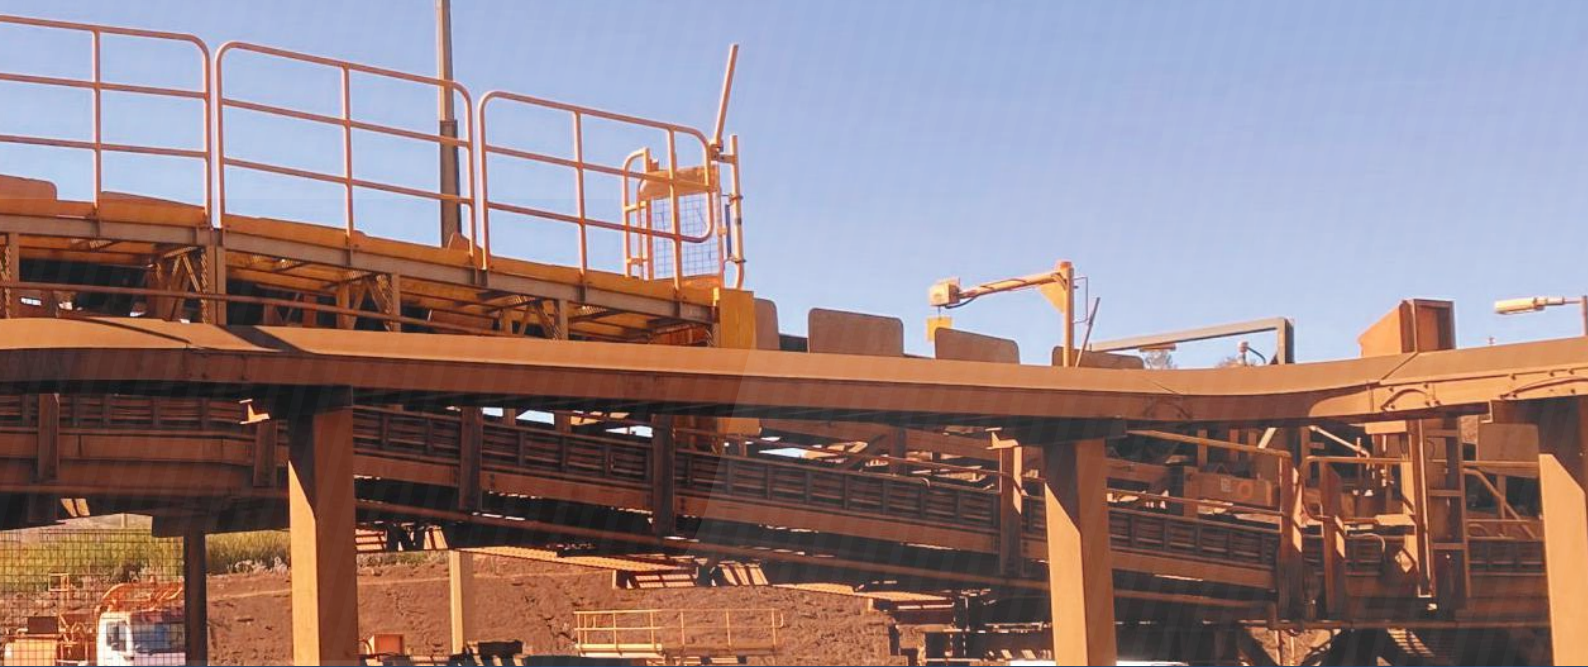
# METAL DETECTOR SERVICE WALKWAY

The walkway is designed to enhance fall protection by installing extra high, heavy-duty steel constructed handrails on top of a sturdy, fixed mesh to walk on, and an isolation gate at either side of the stairway. The handrails ensure that maintenance personnel can't accidentally fall off the top of the conveyor, while the padlocked gates can only be opened by registered site personnel.

The fixed walkway now allows maintenance personnel to safely access the key service areas above and below the conveyor, without the risk of faulty scaffold or unregistered personnel entering the area. The project was designed, constructed and installed on time and on budget.

The service area was located about 10 metres high and previously required scaffold to access, which had very limited fall protection at the highest point. There was also nothing to stop unregistered site personnel from climbing to the top of the conveyor, adding further risk.

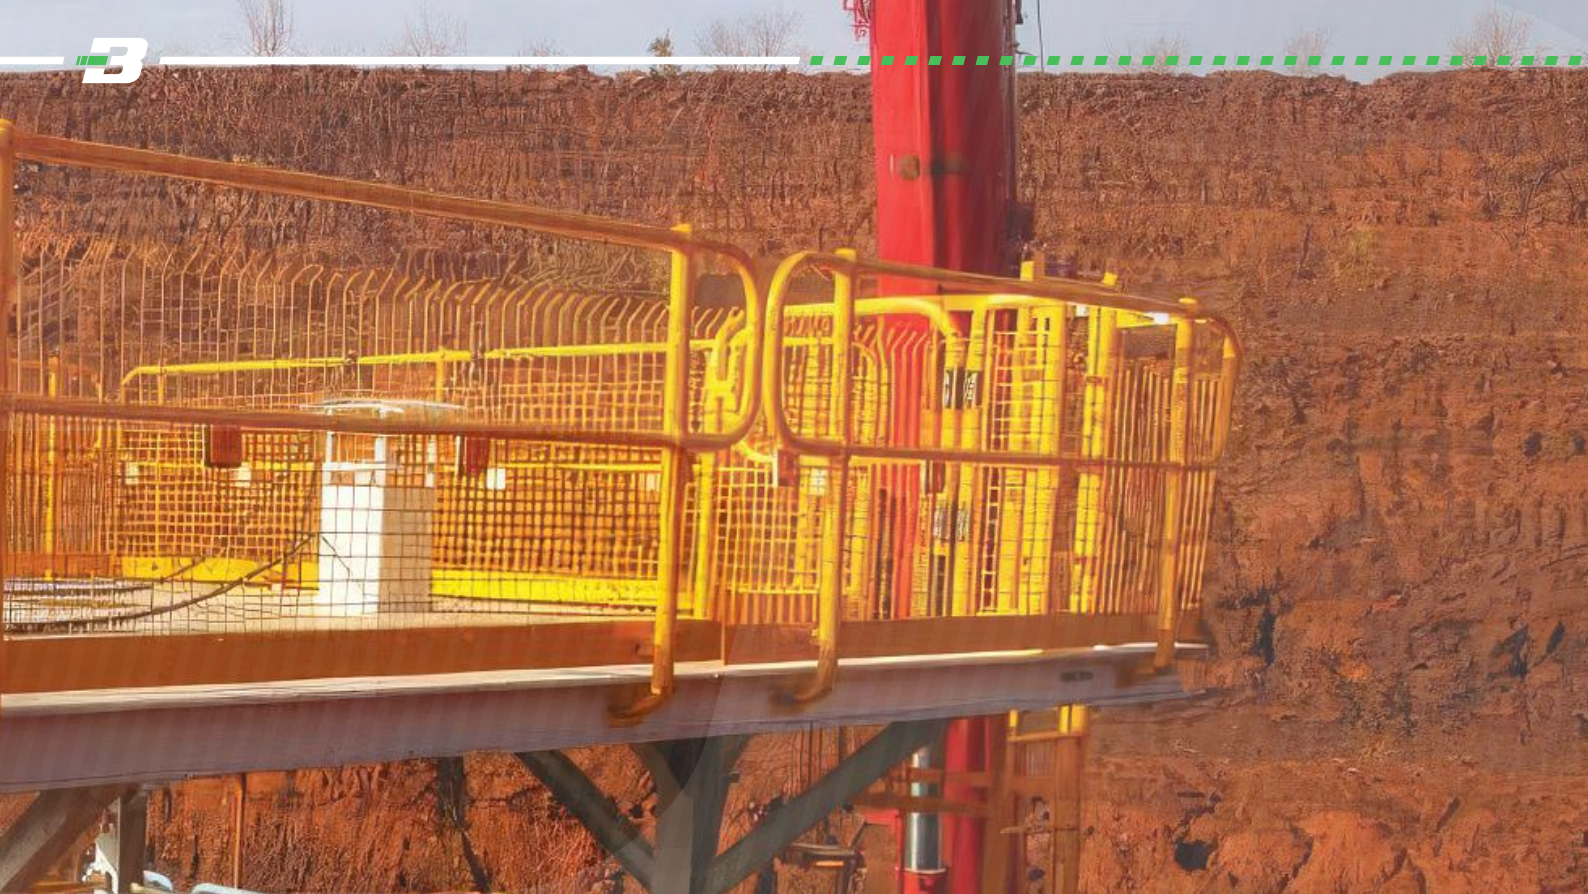
# PRIMARY CRUSHER WORK PLATFORM PROJECT

This platform acts as a cover from the environmental factors such as sun, win and rain as well falling dust and debris.

The roof section while acting as a cover is also a load rated work platform which all welders, air compressors and gas bottles can be stored on.

All extension leads and lines are then run through two specified hatches in the platform floor to bring the necessary power and gas directly to the teams.

The platform sits on the existing crusher structure and provides a safe and demarcated handrail surround. Site personnel can hang their caddy welders from the underside of the platform whilst built in lights and fans provide extra worker comfort.

The platform can be loaded up from the ground with all required tooling and lifted into place by one crane rather than the 5-6 require previously. The work area is cleared considerably from tooling and slip, trips fall hazards whilst providing greater worker comfort.
